**"Application of Linear Array Imaging Techniques to the Real-Time Inspection of  
Airframe Structures and Substructures"**

Final Progress Report: April 15, 1996

NASA Grant Number: NSG-1601

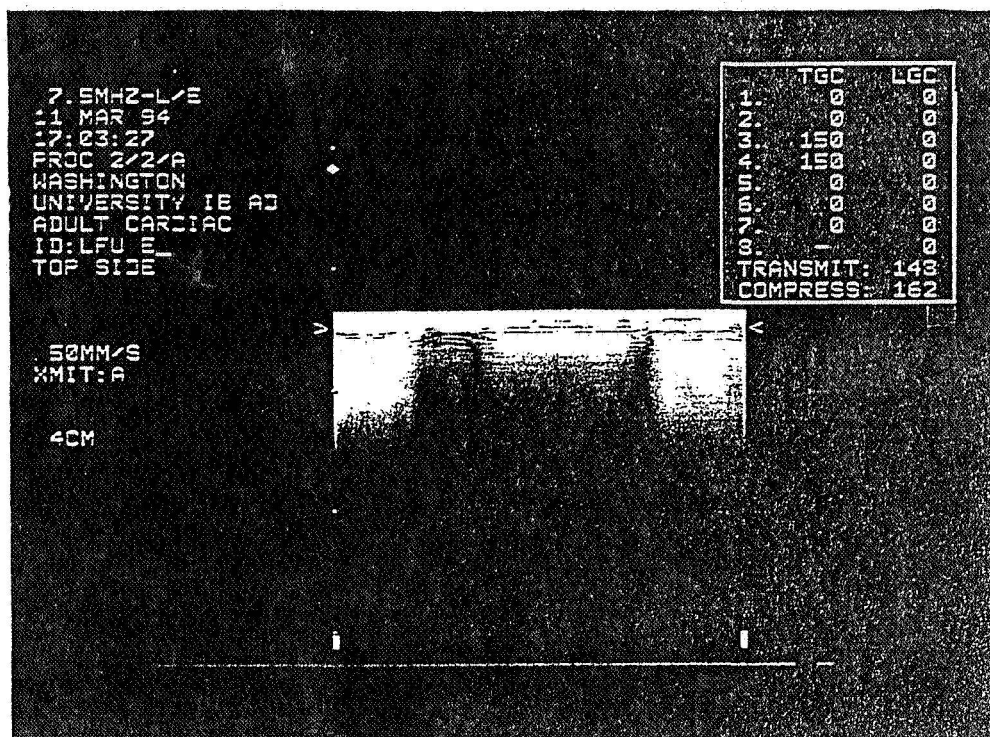
**Figure 17** - Linear array image over the epoxy strip region of sample E.

Figure 17 shows the linear array B-scan image over the epoxy region for the sample with the epoxy strip (sample E). The image was acquired by insonifying the aluminum plate side of the sample (opposite to the side with the epoxy strip). The strip of epoxy region is clearly distinguished from the aluminum plate only regions. The side regions which represent the aluminum/air interface display a reverberation decay pattern that appears bright and long in duration. This is to be expected because the aluminum to air interface presents a large acoustic impedance mismatch and a large portion of the acoustic energy is reflected at this interface. Because aluminum is a rather low-loss material, we see a bright and long decay pattern. The center portion of the image displays the area of the aluminum/epoxy interface. A smaller acoustic impedance mismatch is presented to the acoustic wave in this region and thus some acoustic energy travels into the epoxy region. Because epoxy is more attenuating than aluminum we see that the reverberation pattern appears to be less bright and shorter in duration than the surrounding side regions.

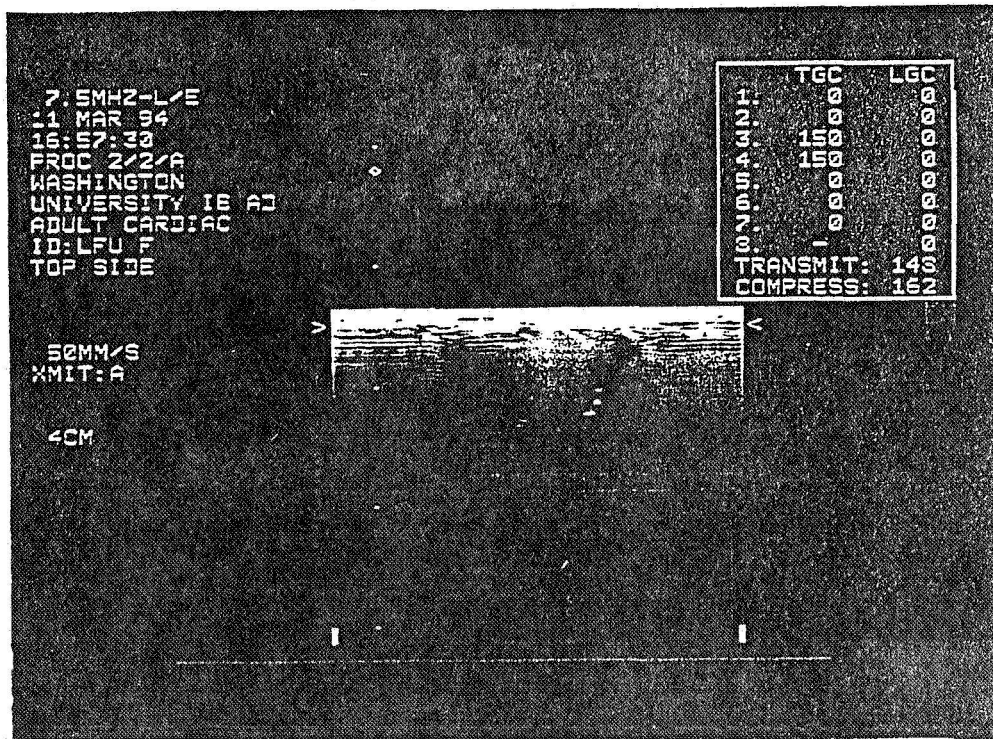
a)

**Figure 18:** Linear array images over the disbonded region for sample F. Figure 18a shows the B-scan image of the disbonded region obtained from the "bottom" side of the specimen. Figure 18b shows the B-scan image of the disbonded region obtained from the "top" side of the specimen.

The results presented above, showing the images of the bonded aluminum plate specimen and the aluminum/epoxy-strip specimen obtained with the linear array and the corresponding ultrasonic rf A-lines obtained with a contact transducer, suggest that linear array imaging can perform a useful role in detecting disbanded regions and providing information describing bond interface characteristics. The disbanded region was easily discernible from the well-banded region in the images. The images also show that the disbanded region looks quite different from that of the surrounding well-banded region in sample F when the images obtained from the "bottom" of the specimen are compared with those obtained from the "top". The relatively "bright" disbond region observed when sample F was imaged from the "bottom" side and the "dark" disbond region observed when the sample was imaged from the "top" side agree with the corresponding echo decay patterns obtained with the contact transducer; i.e., a relatively higher attenuation associated with the disbanded region when interrogated from the "top" when compared with the results obtained from the "bottom".

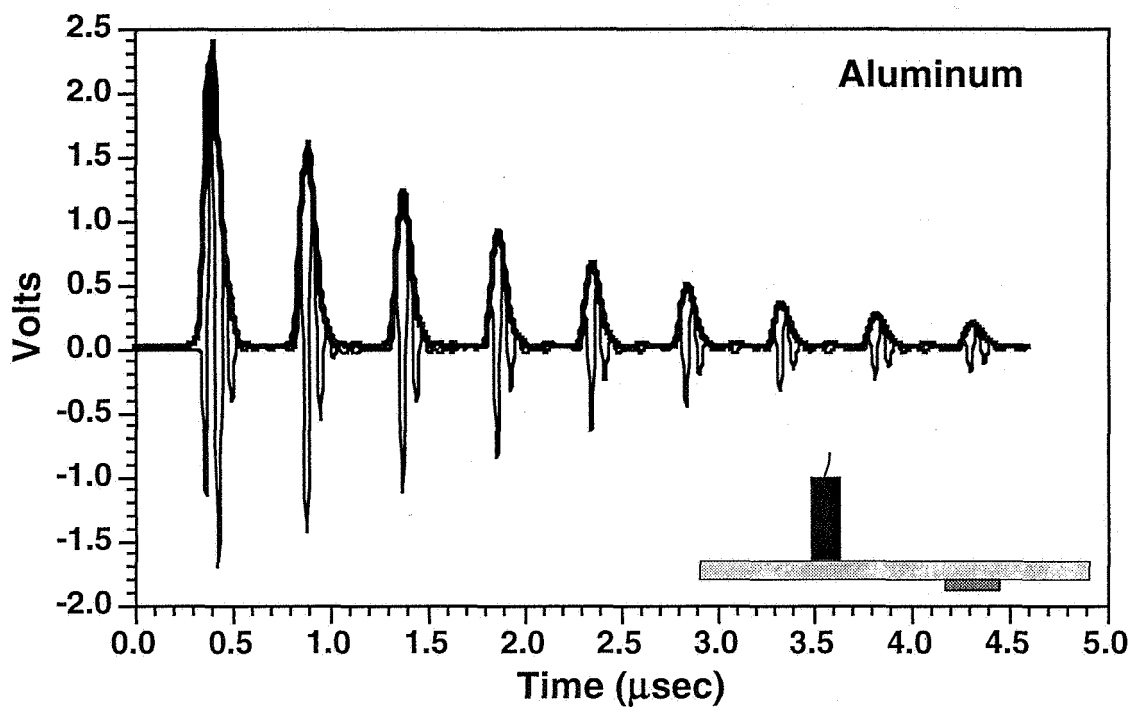
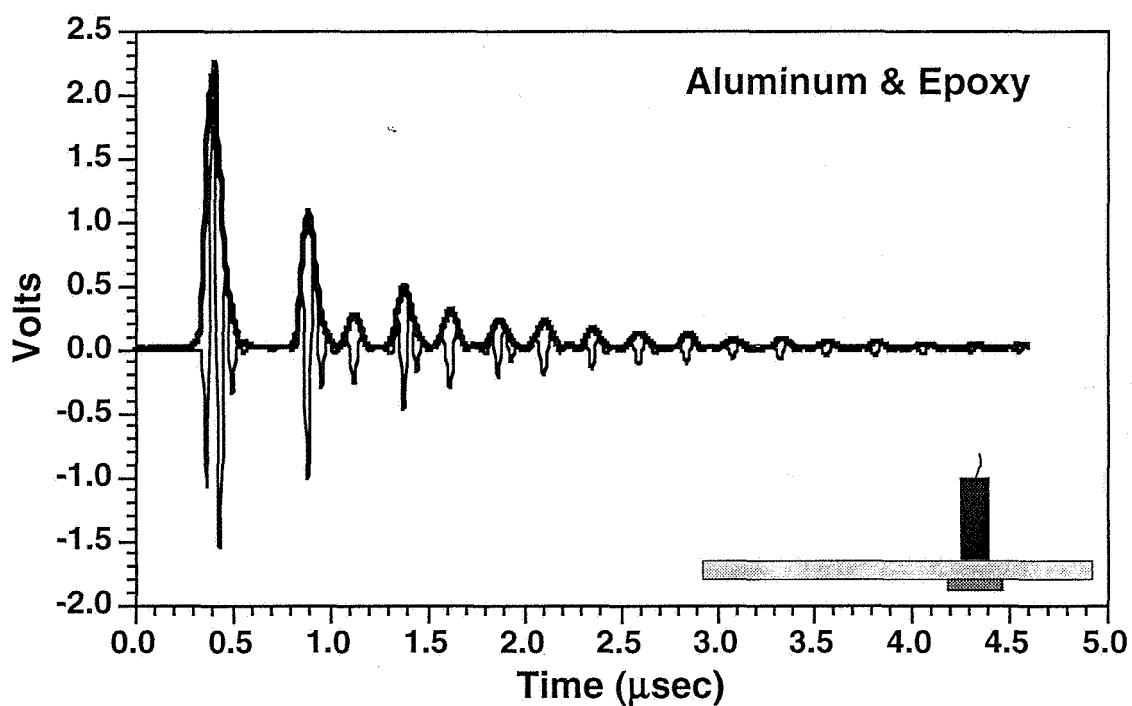
**Figure 19:** The rf and analytic signal of the rf for sample E. a) Insonification of an aluminum only region b) Insonification over the epoxy strip region

In what follows all the figures displaying the signals obtained with the 25 MHz contact transducer will show both the rf and the magnitude of the analytic signal of the rf superimposed to help guide the eye to the encountered interfaces. Figure 19a displays the rf A-line acquired over the aluminum only portion of sample E. The velocity of sound for aluminum is about 6.35 mm/ $\mu$ sec which for a thickness of 0.0615" yields a round trip time (distance traveled is 2 times 0.0615") between reverberations of 0.492  $\mu$ sec. Figure 19b displays the ultrasonic signals over the aluminum/epoxy region of the sample. We see additional reflections inserted between the aluminum echoes. These reflections occur due to the epoxy to air interface. If we compare Figure 19a and 19b we see that the decay patterns decrease more rapidly for the aluminum/epoxy region than for the aluminum only region. As discussed above, this is what we would expect because the ultrasound that travels into the epoxy region decays more rapidly due to the higher attenuation of the epoxy as compared with aluminum. These reverberation decay patterns are responsible for the resultant decay patterns observed in the linear array image of sample E (see Figure 17).

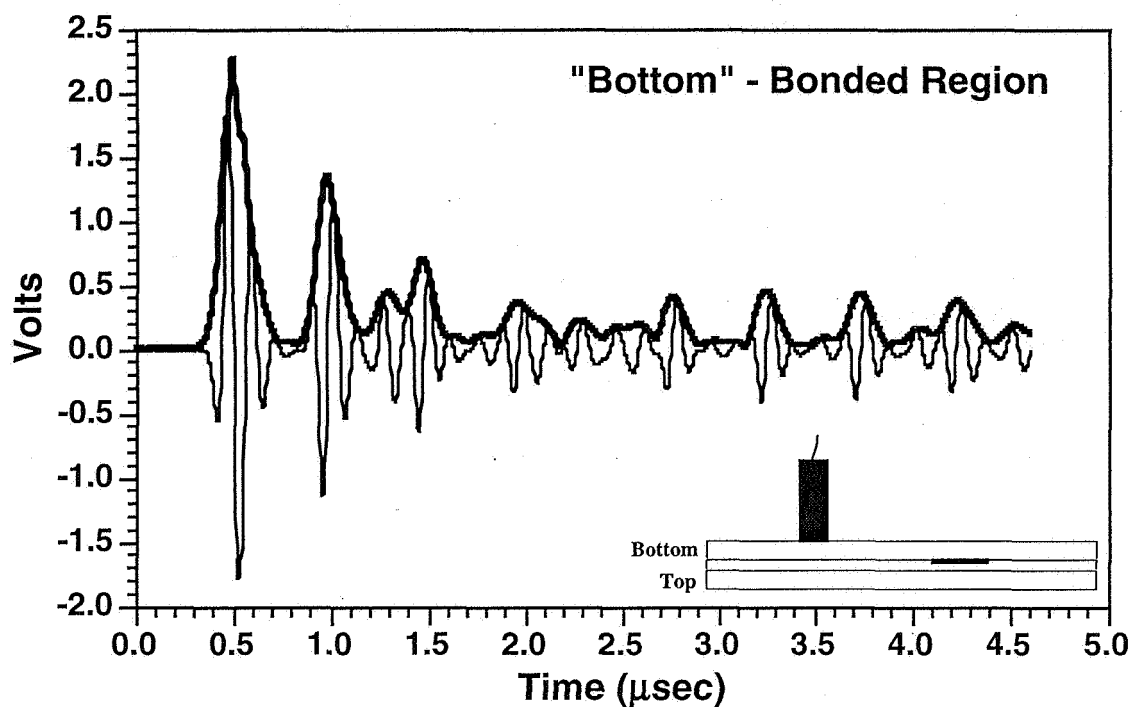
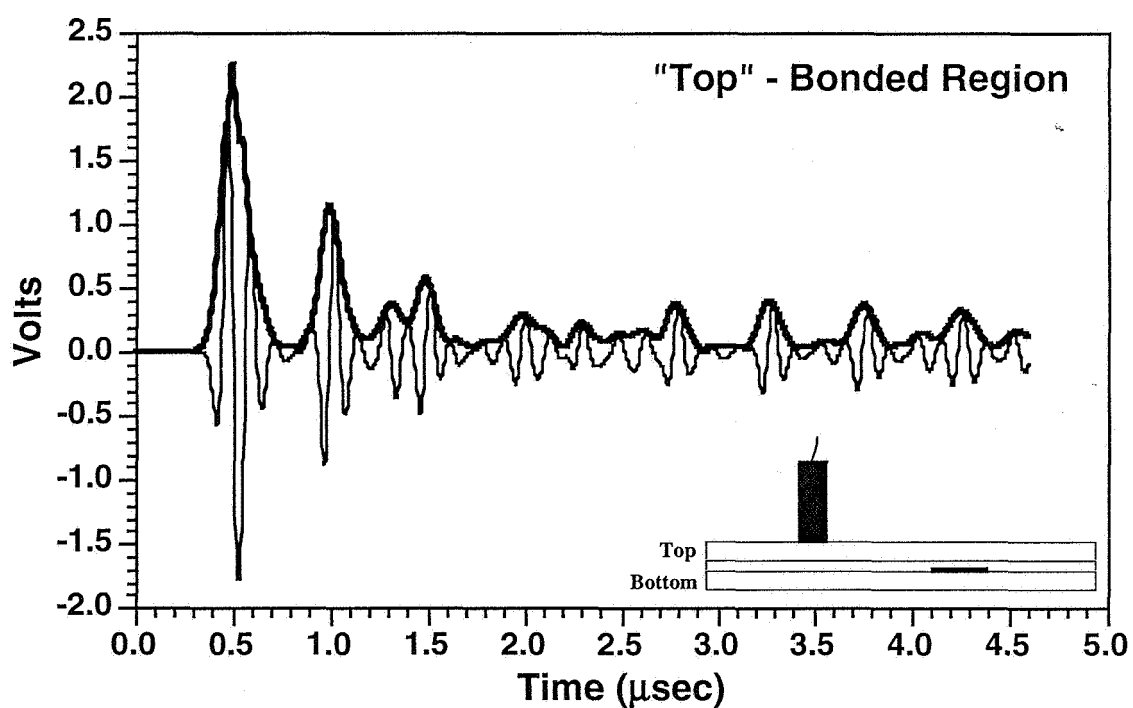
**Figure 20:** The rf and analytic signal of the rf for sample F over the well-bonded area.  
 a) Insonification from the "bottom" side, the side where the paper-tape was adhered b) Insonification from the "top" side

Figures 20 and 21 display the rf A-lines obtained from the bonded aluminum plate sample (sample F). Figure 20a displays the rf and analytic signal for insonification of the "bottom" side in a well-bonded region of sample F. Figure 20b displays the signals when the sample was flipped over and insonified in the same region as Figure 20a but from the opposite side. We see that the signals in 20a and 20b appear to be quite similar. This is to be expected since the thickness of the two aluminum plates are equal.

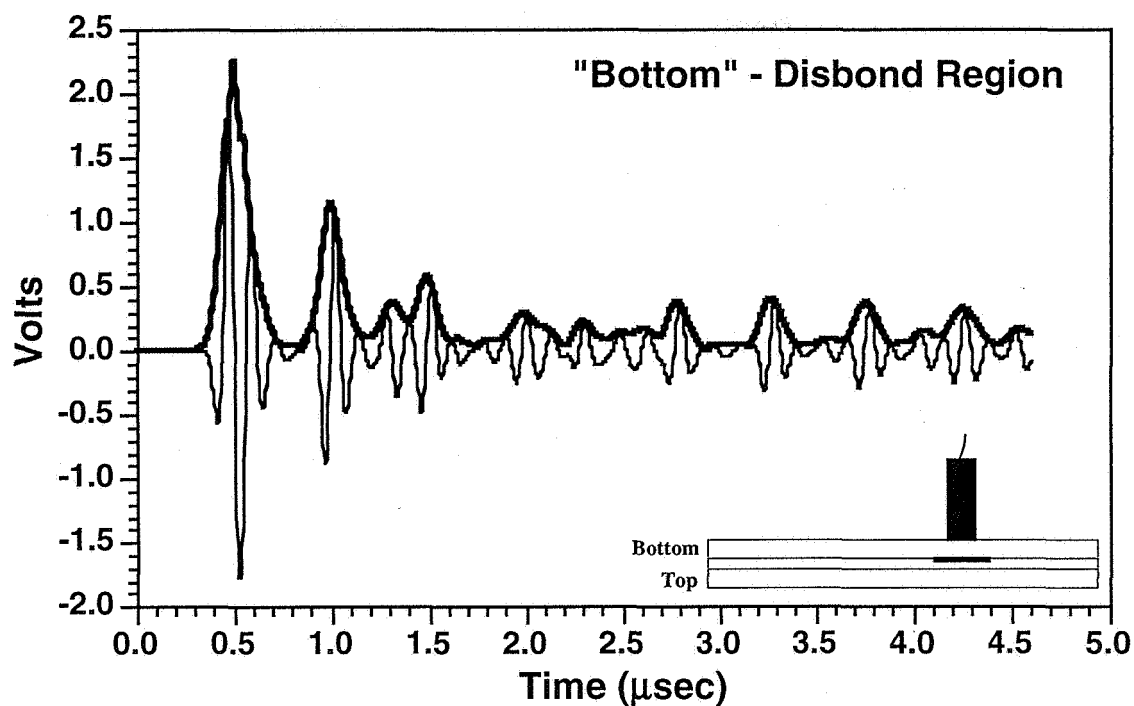
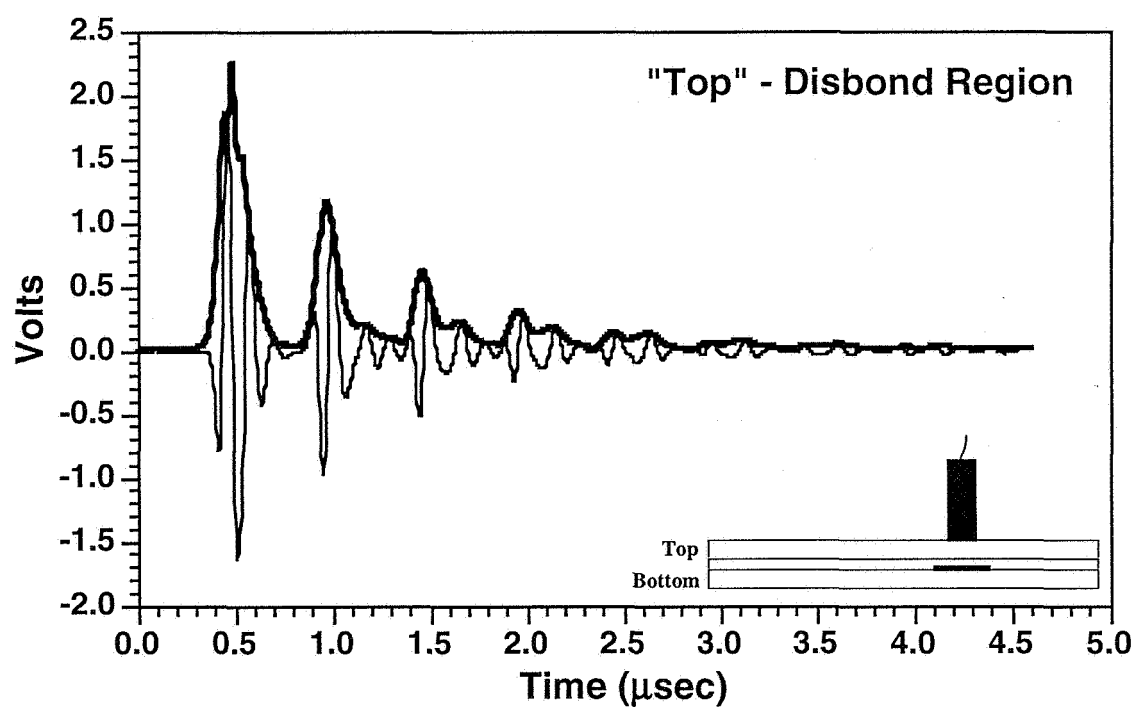
**Figure 21:** The rf and analytic signal of the rf for sample F over the "disbonded" area.  
 a) Insonification from the "bottom" side, the side where the paper-tape was adhered b) Insonification from the "top" side

In Figure 21a sample F was insonified from the "bottom" side of the specimen (the side to which the paper-tape was applied) with the transducer positioned over the region of the disbond. Figure 21b displays the rf A-line and analytic signal for the same region except that the sample is insonified from the "top" side of the sample. The rf signal for insonification of the "top" side decays more rapidly than the rf obtained from insonifying the "bottom" side. As discussed above because epoxy is more attenuating than aluminum the epoxy layer dampens the decay pattern. If we compare Figure 21a with Figures 20a and 20b we see that they all appear very similar.

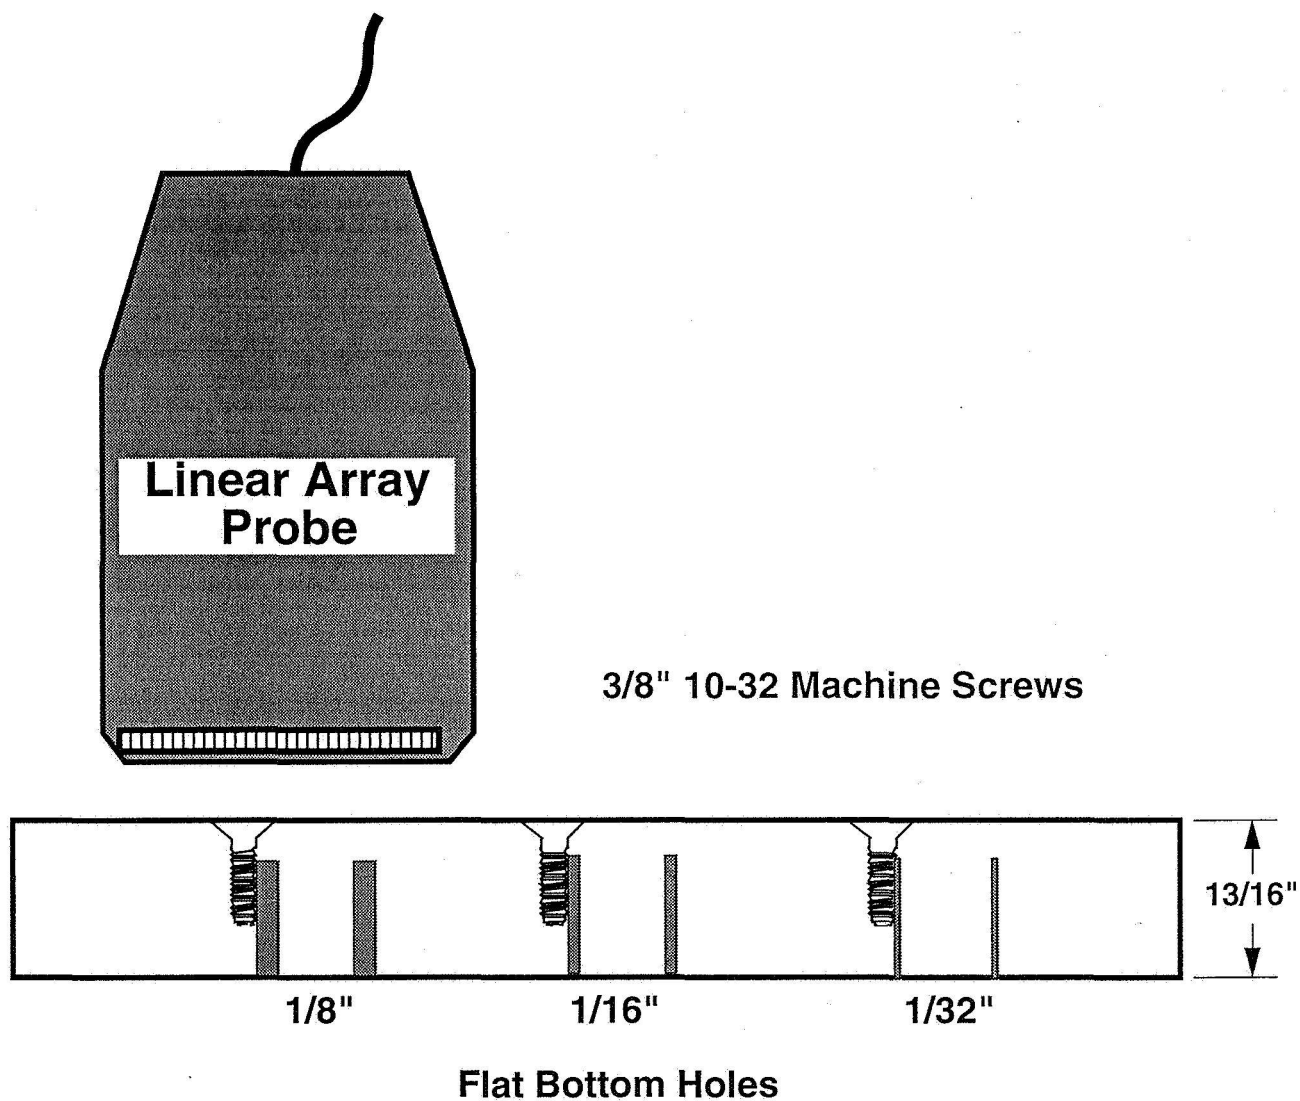
## Flat-Bottom Hole Under Head of Fastener

**Figure 22:** Illustration of the measurement setup for the interrogation of "flaws" located under the head of fasteners

A Hewlett-Packard Sonos 2500, configured in the 7.5 MHz linear array imaging mode, was employed to interrogate a series of specimens with intentional flaws. One genre of specimen contained simulated "cracks" under fasteners. Flat-bottom holes were drilled under the fasteners (3/8" 10-32 machine screws) to represent cracks in a plane parallel to the face of the linear array probe. These specimens were interrogated in a water bath with the linear array insonifying the top surface of the specimen as illustrated in Figure 22. Duplicate flat-bottom holes were drilled midway between the fasteners to aid in the initial determination of the type of echo the investigator should look for. The dimensions of the fasteners and the simulated cracks for this type of specimen are also displayed in the figure.

Flat-Bottom Hole Under Head of Fasteners	
(3/8" 10-32 machine screws were used for the fasteners)	
Flat-Bottom Hole Diameter	Was the Flaw Seen?
1/8"	yes
1/16"	yes
1/32"	no

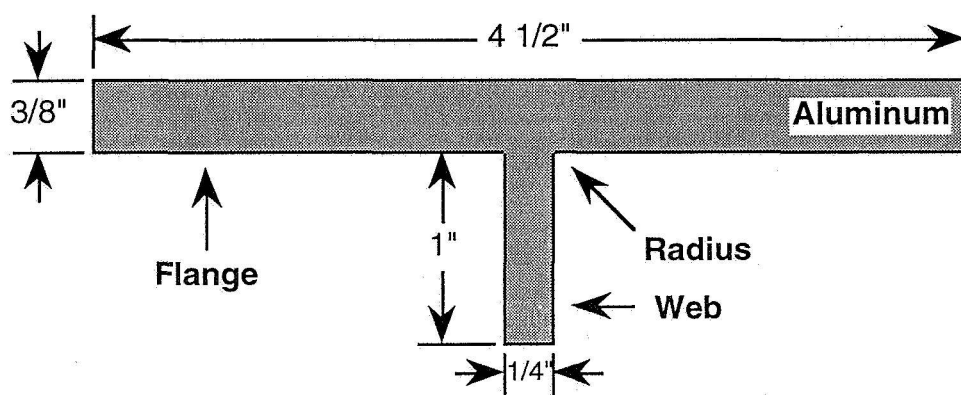
## Aluminum "T" Dimensions

**Figure 23:** Sample dimensions for the interrogation of "flaws" in the flange, web, and radius of "I"-shaped stiffener support structures. "T"-shaped aluminum samples were substituted for the "I"-shaped stiffener.

Specimens designed to mimic a typical "I"-shaped stiffener support structure component (that might be found as part of the underlying airframe substructure) were investigated next. In airframe applications the flange of a stiffener is typically attached to the skin of the structure it is supporting, thus ultrasonic inspections are limited to accessing the "I"-beam through one of its flanges. To simulate the cracks in this type of support structure, flat-bottom holes were drilled in the flange and web regions as well as the region where the web connects to the flange, (referred to as the radius region). Due to the availability of material aluminum "T" 's were substituted for the "I"-shaped stiffeners. Figure 23 displays the aluminum sample dimensions and Figures 24, 25 and 26 depict the measurement setups. Specific details describing the flaw sizes, locations and imaging observations are summarized in Tables 2,3,4.

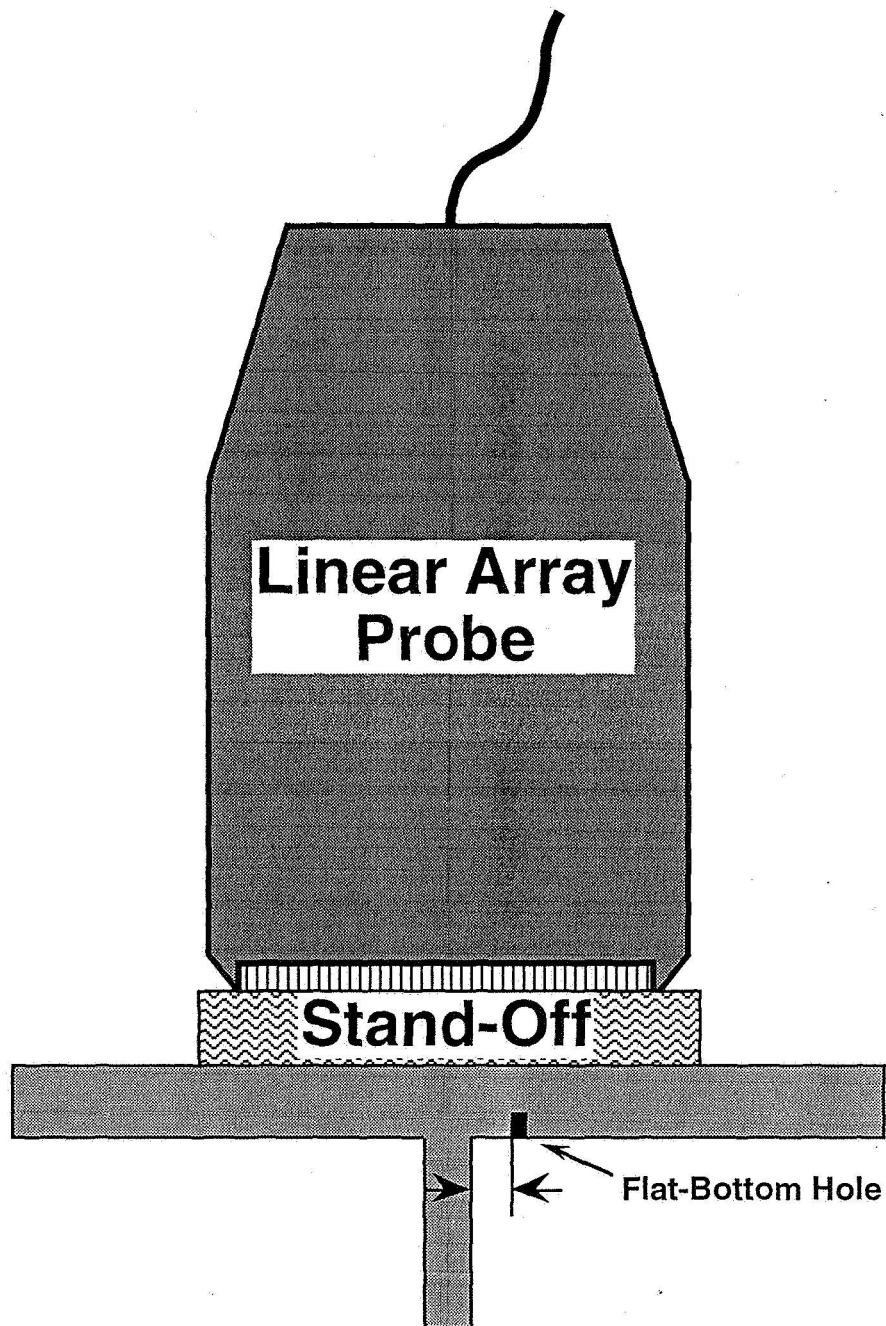
## Flat-Bottom Hole in Flange

**Figure 24:** Illustration of the measurement setup for the interrogation of "flaws" in the flange of a stiffener support structure

The observations for the linear array interrogations of flaws in the flange of "T"-shaped stiffener support structures are summarized in Table 2. The linear array was mounted to a gelatin standoff and positioned across the web of the stiffener as shown in Figure 24. The B-scan image displayed parallel horizontal lines on the left and right side of the image and a darkened region in the center of the image. The horizontal lines (echoes) represent the reverberations from the back wall of the flanges and the darkened center region the web area of the specimen. All the flat-bottom hole echoes appear as a reverberation pattern of short horizontal lines. The first echo of the pattern appears approximately midway between the front wall echo and first back wall echo from the flanges. The flaws for all the diameter flat-bottom holes were observed.

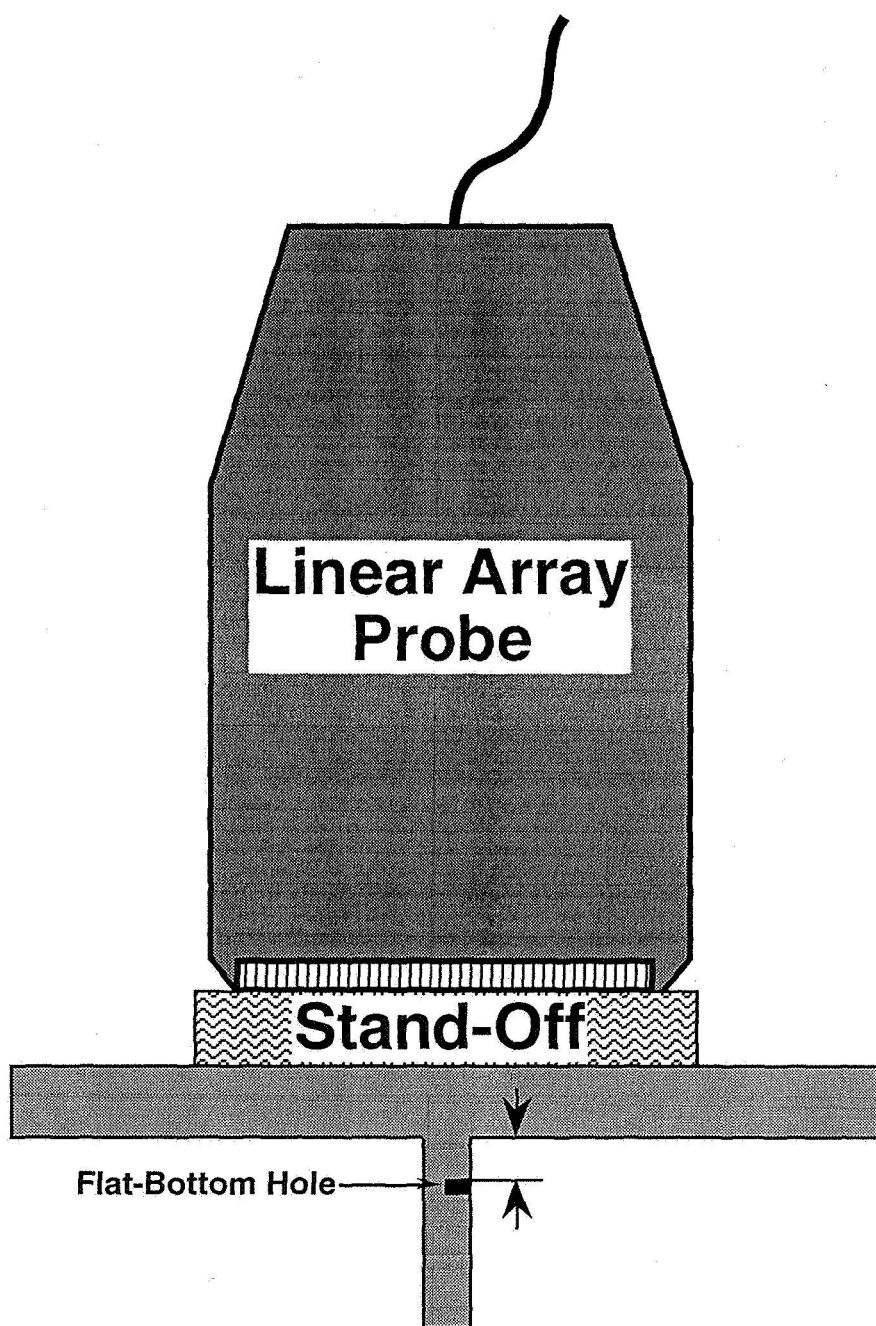
## Flat-Bottom Hole in Web

**Figure 25:** Illustration of the measurement setup for the interrogation of "flaws" in the web of a stiffener support structure

Table 3 summarizes the observations for the linear array interrogations of flaws in the web of "T"-shaped stiffener support structures. The linear array was mounted to a gelatin standoff and positioned across the web of the stiffener as illustrated in Figure 25. The B-scan image displayed parallel horizontal lines on the left and right side of the image and a darkened region in the center of the image. Again the horizontal lines (echoes) represent the reverberations from the back wall of the flanges and the darkened center region the web area of the specimen. All the flat-bottom hole echoes appear as a reverberation pattern of short horizontal lines in the darkened center region (the web region). Detection of all the flaws was achieved except for the deepest 1/4", 1/8", and the 1/32" flaws.

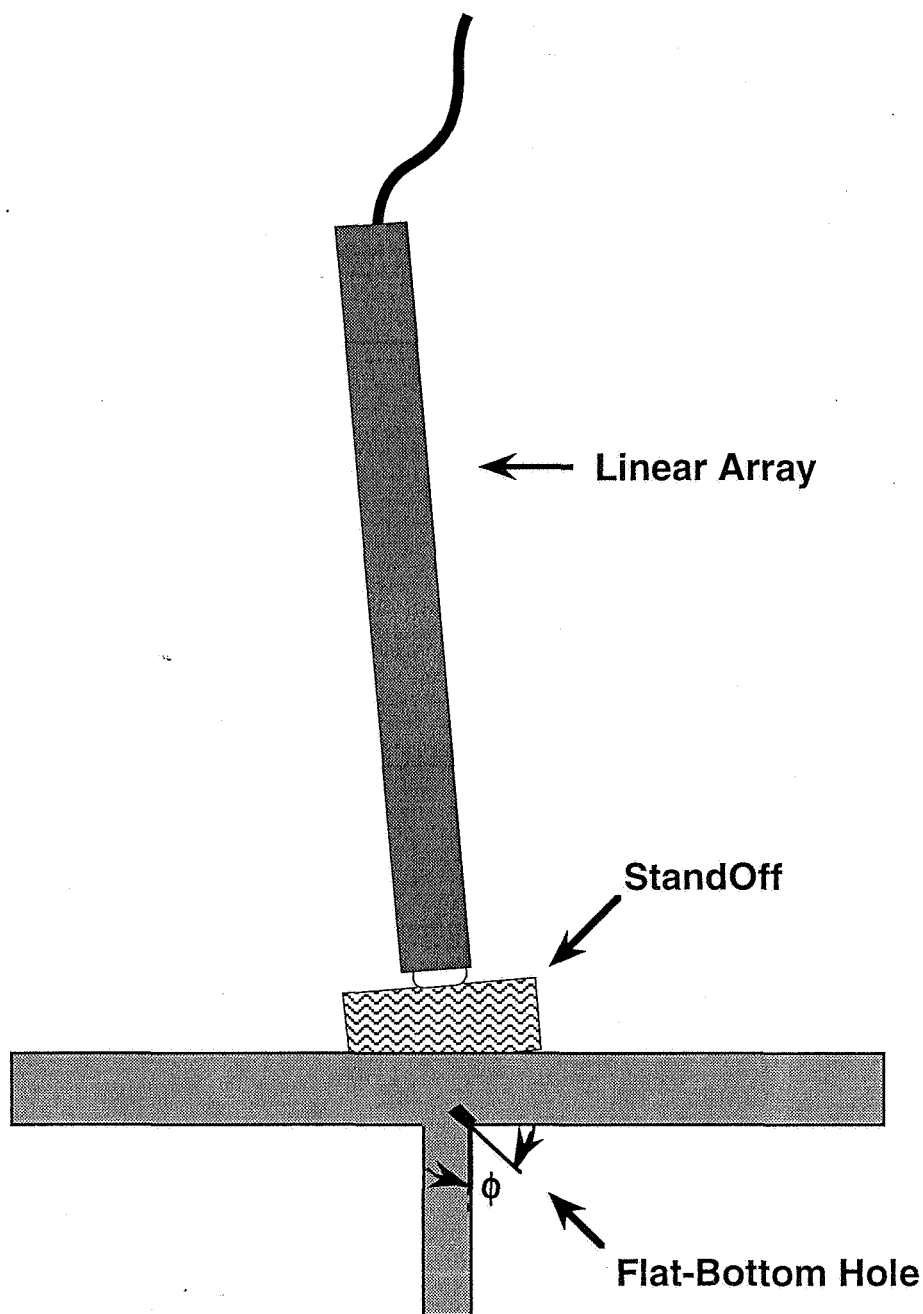
## Flat-Bottom Hole in Radius

**Figure 26:** Illustration of the measurement setup for the interrogation of "flaws" in the radius of a stiffener support structure

The observations for the flaws in the radius of "T"-shaped stiffener support structures are summarized in Table 4. The linear array was mounted to a gelatin standoff and positioned aligned along the web of the stiffener and tilted approximately 5° with respect to the normal of the flange, as depicted in Figure 26. The echo decay pattern from the flaw appears as a series of short horizontal lines interspersed with the series of horizontal lines (echoes from where the

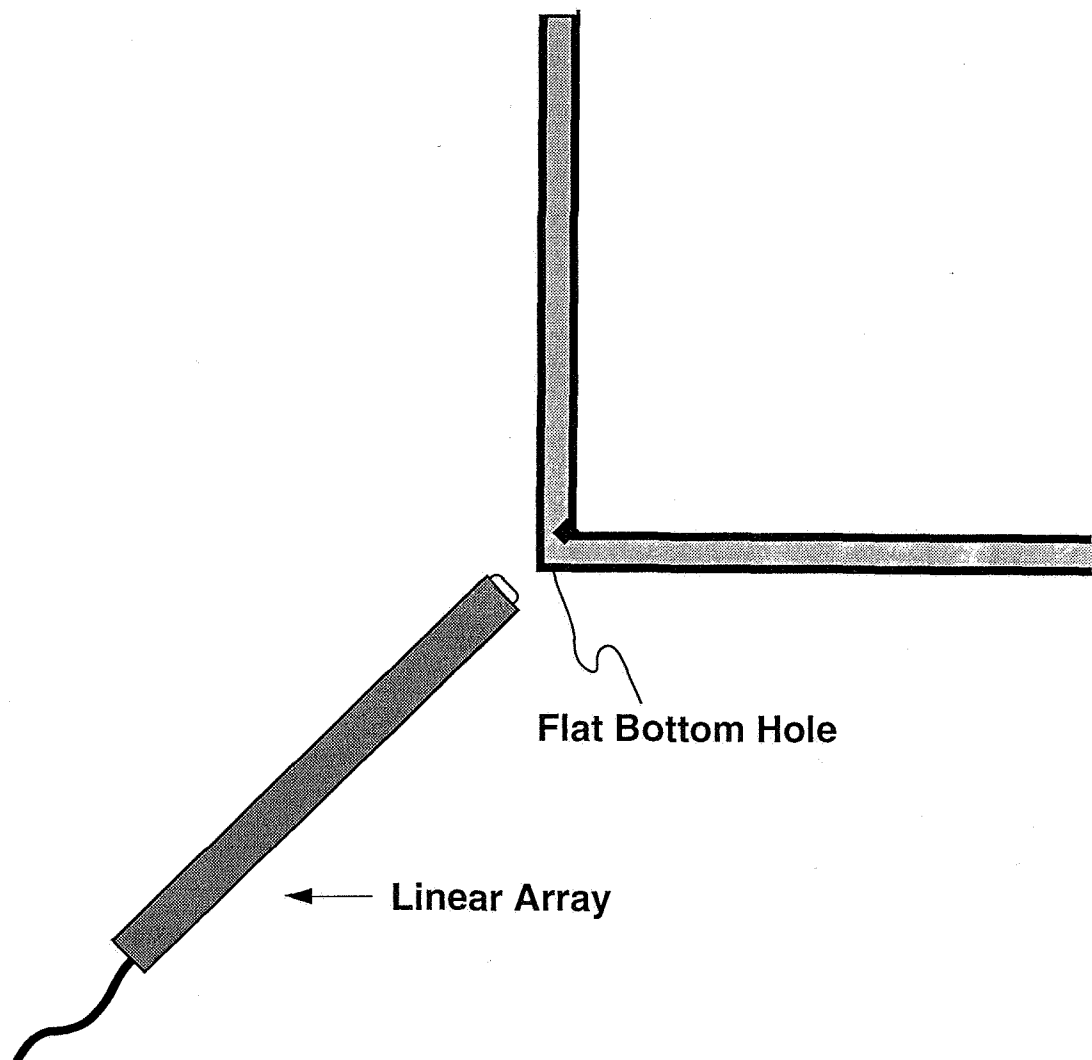
## Flat-Bottom Hole in Inclusive Angle of "L"-Shape Stiffener

**Figure 27:** Illustration of the measurement setup for the interrogation of "flaws" in the inclusive angle of an "L"-shaped stiffener

Linear array imaging techniques were applied to the interrogation of solid aluminum angles ("L" stiffeners) with flat-bottom holes of specific diameters drilled into the radius of the inclusive and exclusive angle of the "L" as depicted in Figures 27 and 28. The radii were interrogated with the right-angle specimens immersed in a water bath and the linear array positioned from the opposite side to which the flat-bottom hole was drilled. The linear array was oriented such that the images produced were formed with the array orthogonal to the plane of the right-angle. Table 5 summarizes the flaw sizes interrogated.

Table 5 summarizes the observations for the linear array interrogations of flaws in the radius of "L"-shaped stiffener support structures. The specimens were interrogated in a water bath as illustrated in Figures 27 and 28.

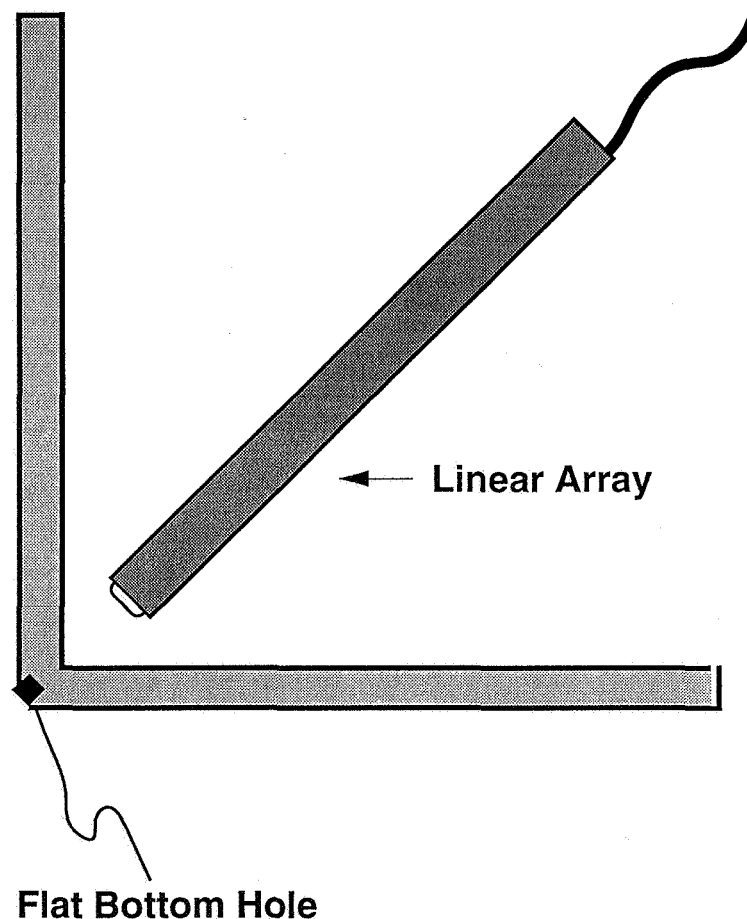
## Flat-Bottom Hole in Exclusive Angle of "L"-Shape Stiffener

**Figure 28:** Illustration of the measurement setup for the interrogation of "flaws" in the exclusive angle of an "L"-shaped stiffener
